LIVESTOCK AND VEHICULAR UNDERPASSES SUPPLEMENT TO FINAL REPORT 98 CASE STUDIES

LIVESTOCK AND VEHICULAR UNDERPASSES

CASE STUDIES

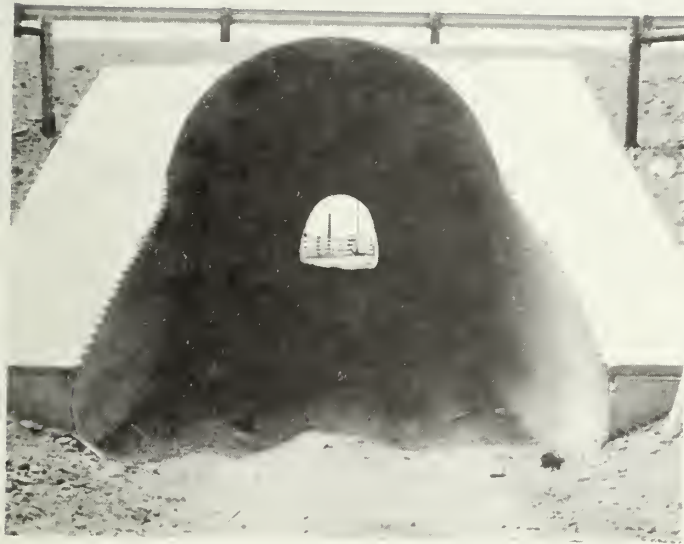
No. End Looking So.

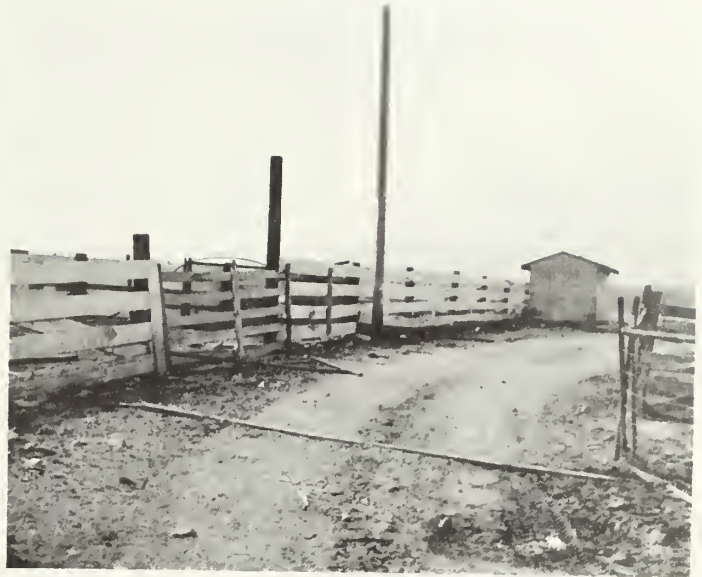
So. End Looking So.

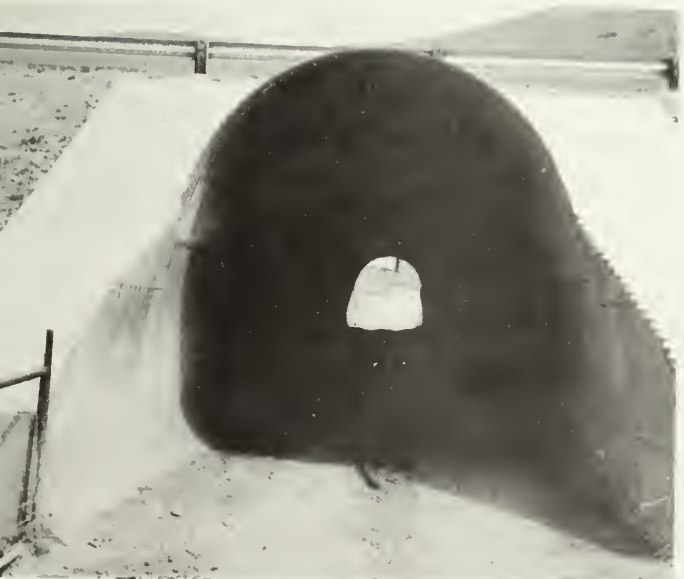
So. End Looking No.

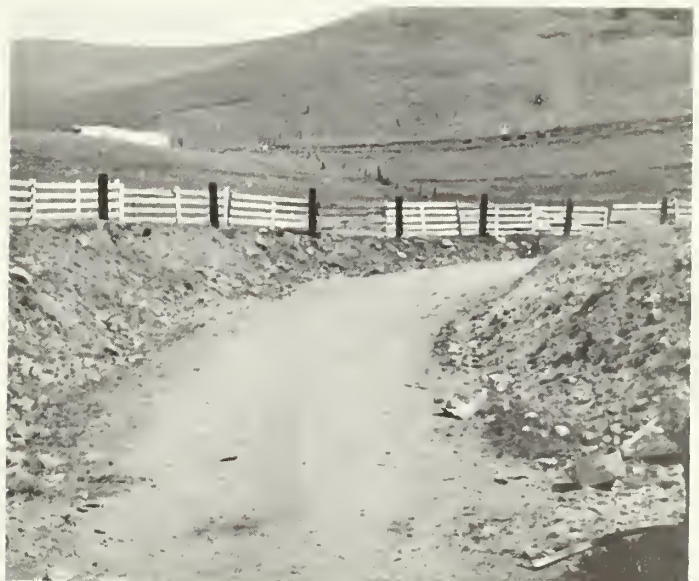
No. End Looking No.

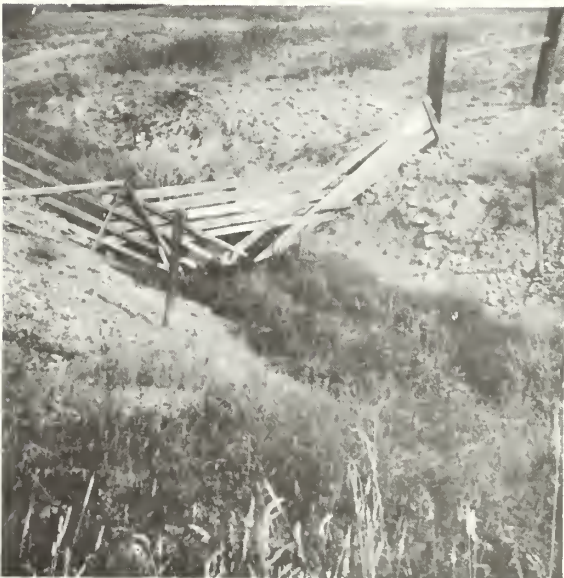
Looking East from EAST ENTRANCE
into swampy drainage bottom

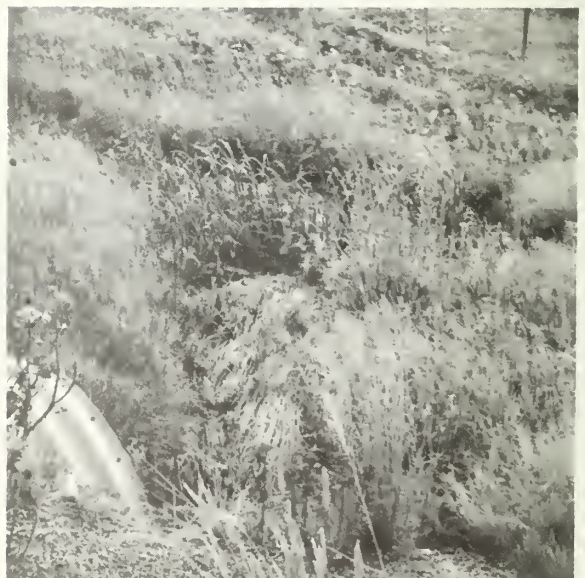
Looking West from WEST ENTRANCE
into swampy drainage bottom

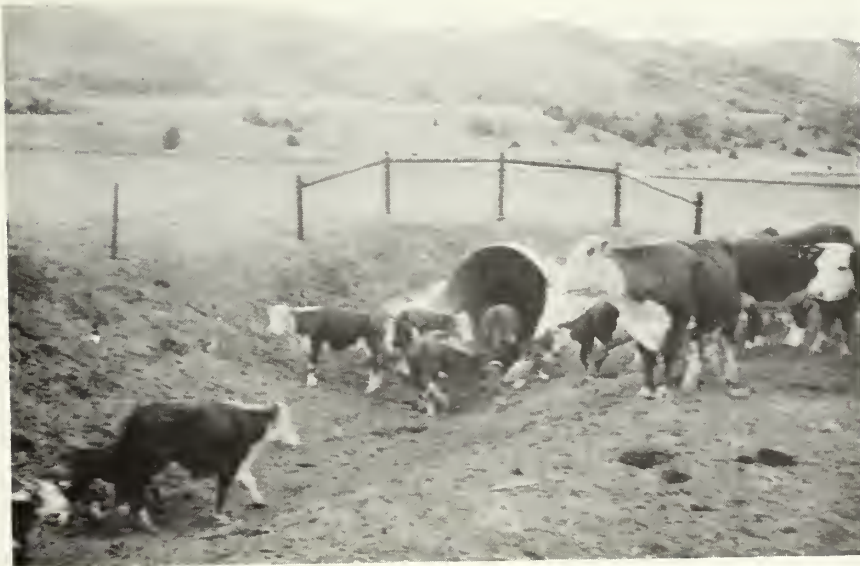
96" Stockpass

REMARKS: Two deficiencies seem apparent: (1) undersize of stockpass, and (2) the fact it was dug into a sidehill.

This structure would have to be considered less than adequate.

The landowner has tried feed and salt to lure them through the stockpass, leaving them alone, pushing them, and even considered stringing lights at this point. Over a three-day period, the landowner said all cows went through but six calves remained south in the holding corral. These calves would normally have difficulty locating their rightful mother. He is learning to live with a fairly difficult situation, but one in which he participated and preferred to any alternate view of the circumstances. He did mention his desire to remove the wing fence from the top of his stockpass into the metal pipe. Refer to photograph of north entrance. This will not be a costly item and may help somewhat.

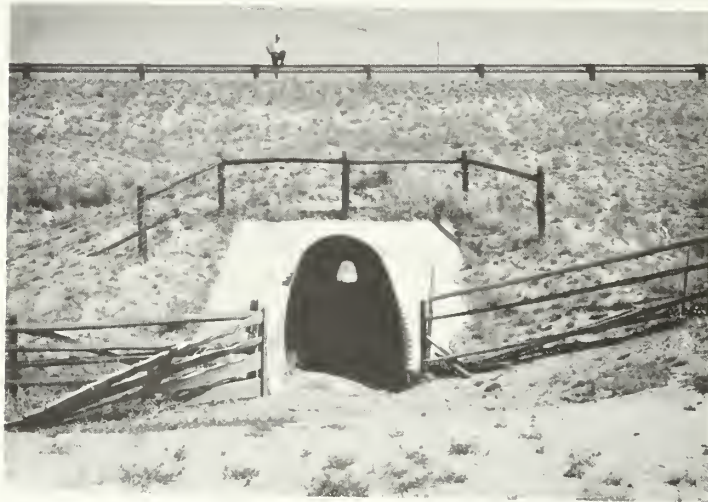
Looking north, note fencing.

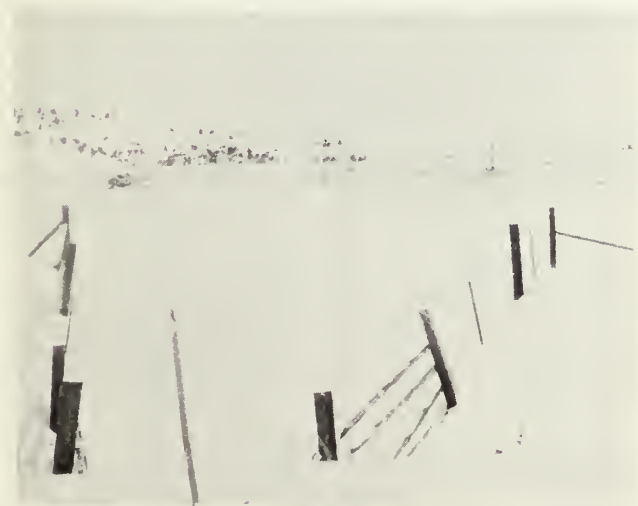
Looking North from North End:
Snow is about 2' deep and drifting.

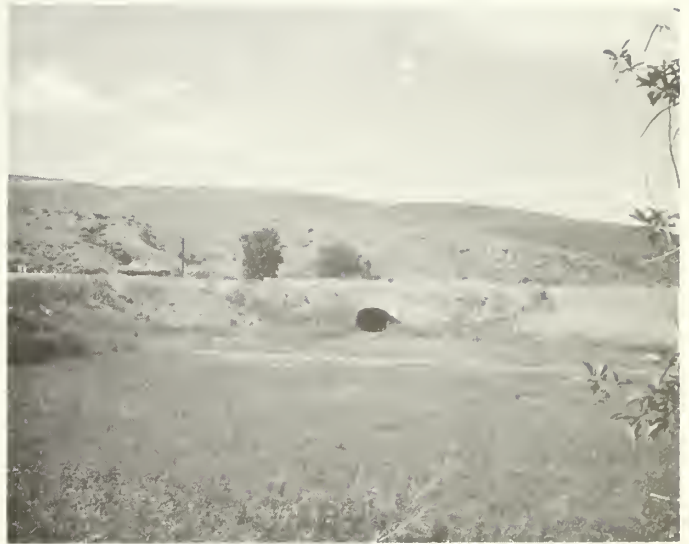
SOUTH ENTRANCE
Grade Crossing at Left

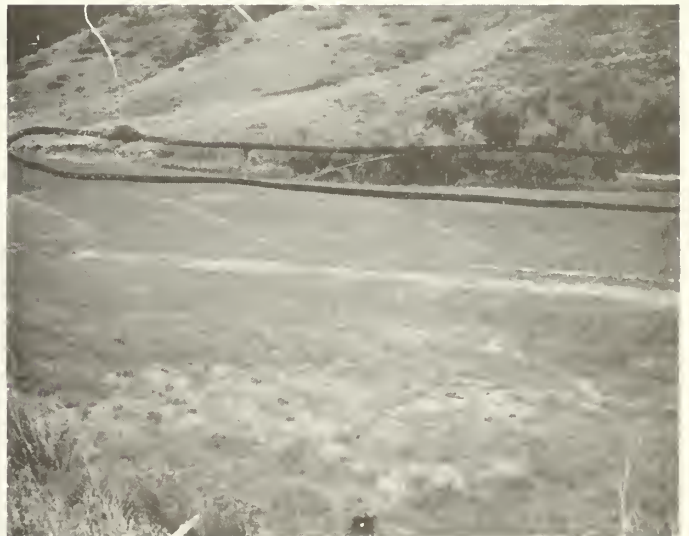
Looking South from
SOUTH ENTRANCE
Note: Road in background

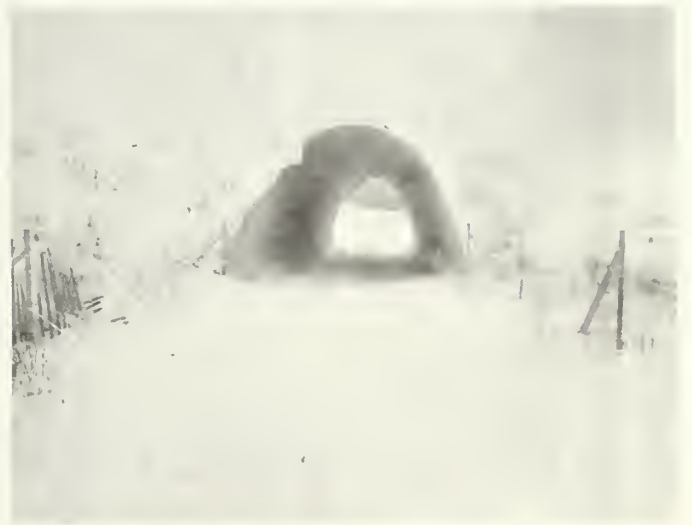
NORTH ENTRANCE; about 1' of snow

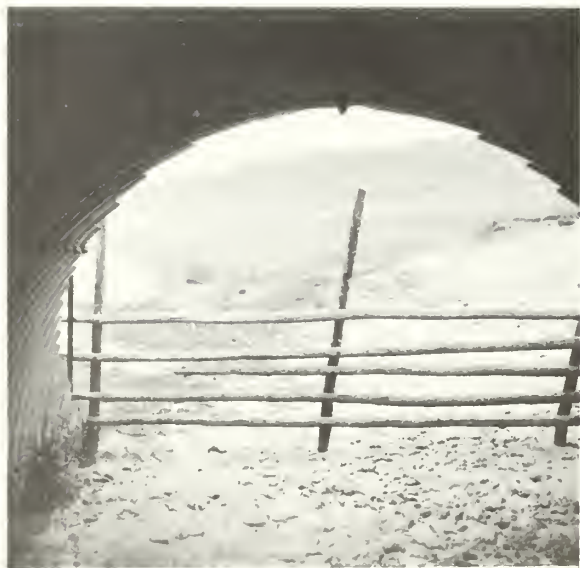
Looking east from EAST ENTRANCE; water flows from East to West

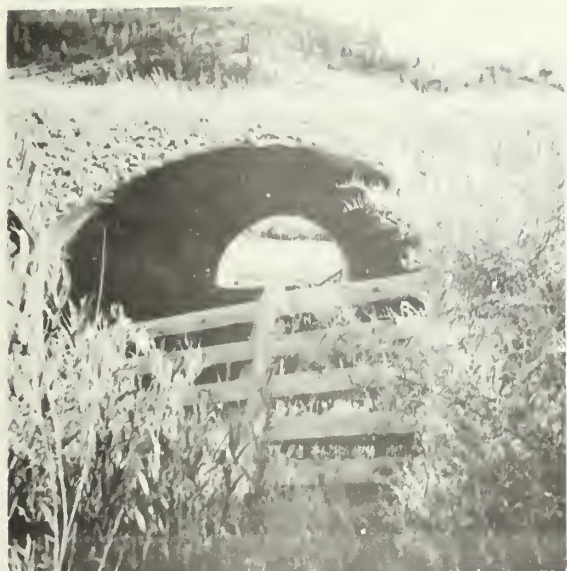
NORTH ENTRANCE

SPECIFIC PROBLEMS: Elevation of bottom of structure is too low - drainage becomes a problem. It is set in a flat location, also. The owner would like a gate near the stockpass to get the cows off the highway. They can climb between the post and culvert ends, and get onto the right-of-way. Drifting snow causes a problem, also.

REMARKS: This structure was possibly set too low during construction. Conditions brought about by natural change may have caused this; for example, building up of topsoil by silting, overflow, or tilling. This would make the stockpass entrance lower than the surrounding terrain.

The wing fences can be attached to most corrugated metal pipes by stringing the wire from the pipe end bolt holes to the post.

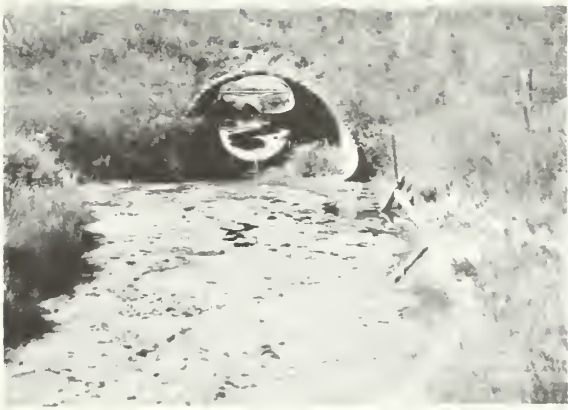
EAST ENTRANCE (Fenced)

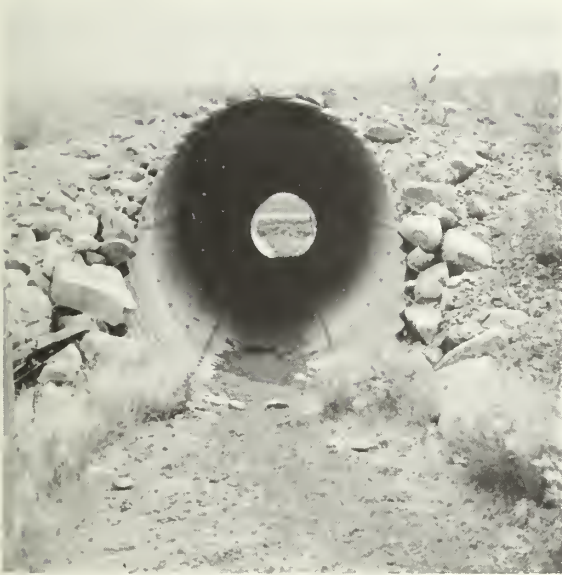
NORTH ENTRANCE

During construction, several holes were drilled west by southwest of the pipe, and as a result there has been a continual stream of water running down the borrow pit, creating a boggy condition at the south end of the pipe. The owner periodically constructs a ditch diverting its flow into the 36" drain located east of the stockpass, 130 feet.

REMARKS: Whereas a 36" pipe was installed when the 7½' stockpass-drainage was lengthened five years ago, it did not seem to affect the runoff appreciably. There is still a silt collection and a boggy south entrance during wet periods. Only recommendation would be stabilization of the area near the pipe, and a better drainage pattern to utilize the 36" drain pipe, if at all possible.

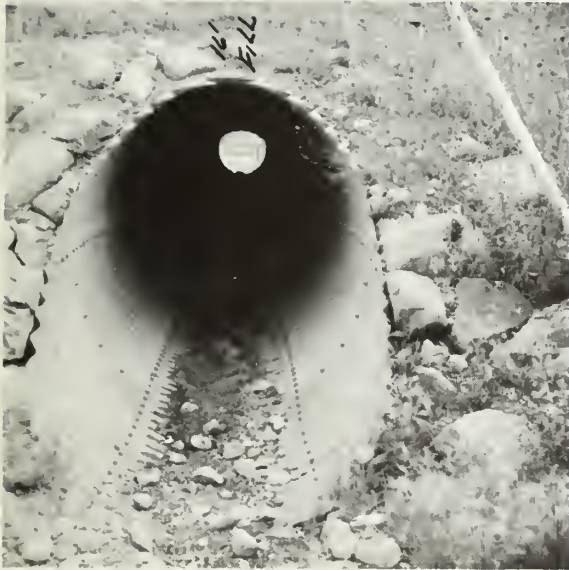
NORTH ENTRANCE

REMARKS: Normally a structural plate pipe is installed all at one time, allowing for fill stress by squeezing the circular pipe in an oblong shape to settle into its proper designed dimensions. If one must be lengthened, proper design, construction, and inspection must take place to ensure the pipe maintains its designed dimensions.

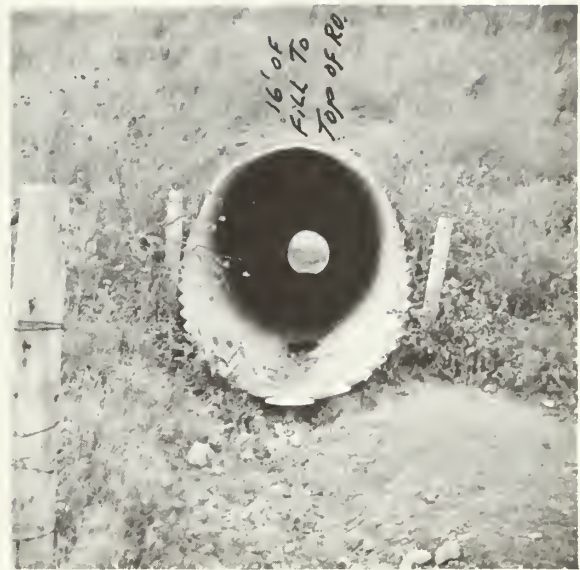
SOUTH ENTRANCE

Undesirable access and footing

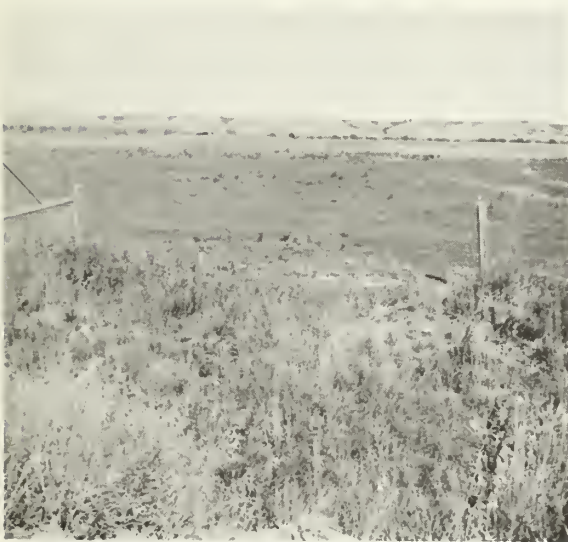
Looking North from NORTH ENTRANCE
Notice Borrow Area

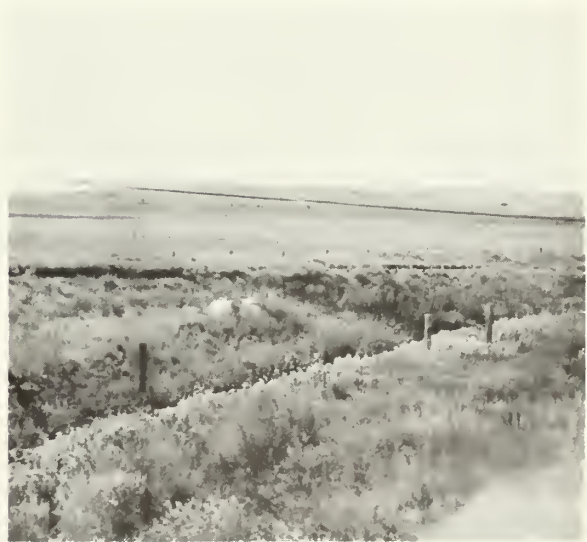
Looking South from SOUTH ENTRANCE
Notice right of way fence, railroad

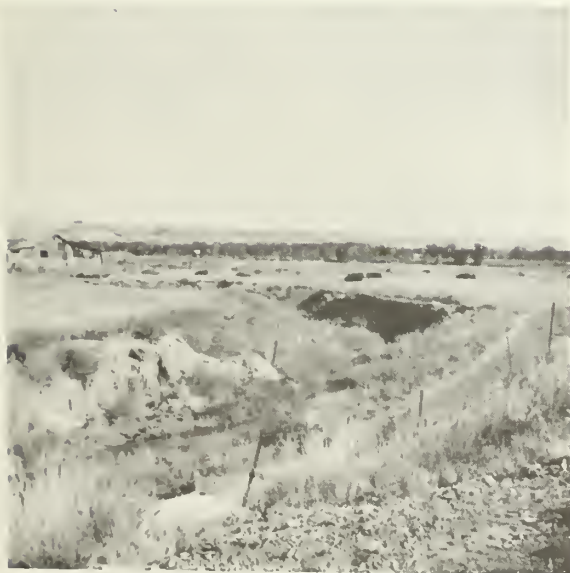
Looking North from NORTHWEST ENTRANCE,
showing coulee, creek and cattle trail

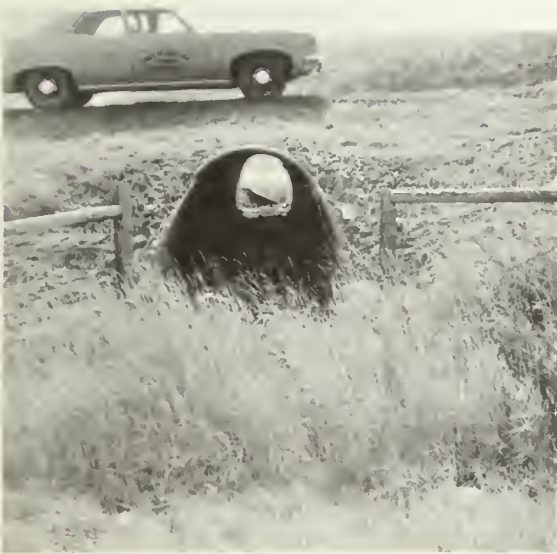
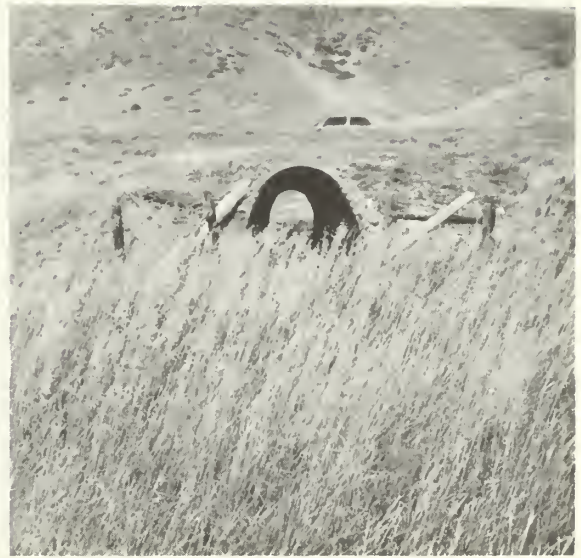
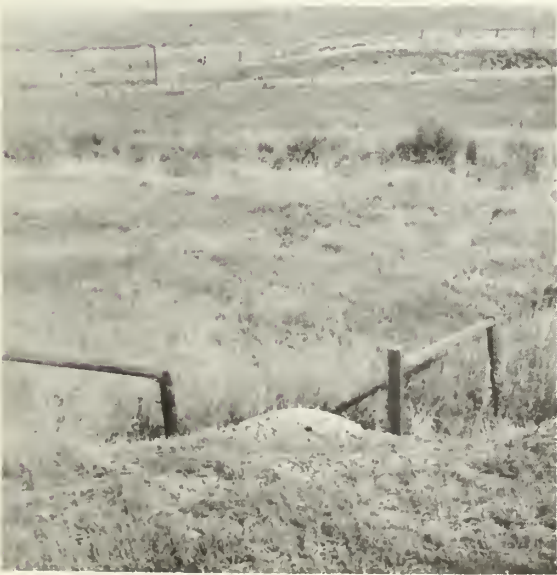
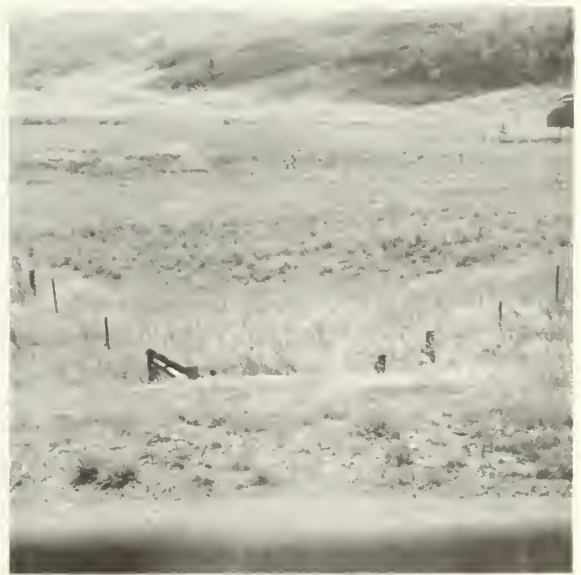
F 235 (18)
ARMINGTON-RAYNESFORD

SPECIFIC PROBLEMS: This is located in a recessed area and snow and water create problems. It fills with water in the spring from Otter Creek, which is located just north of the north entrance. Water remains in the pipe until late July or early August. The owner said that both ends fill with snow from storms and from snow plowed by State-owned equipment. He has no alternative but to keep digging it out. He feels the State should extend the pipe at least 6 feet on each end and allow him to construct snow fences on the right-of-way to protect the pipe openings. This was installed to replace a concrete 6' x 6' bridge that served as a stockpass under the original highway. A change of alignment made it necessary to install the new stockpass approximately 300 yards west of the old structure. At that time, he indicated to the Project Engineer that the new location was a poor one because of drifting snow and water. This winter he is going to request that the State extend the pipe on each end and permit him to attach some type of hinged doors in an effort to keep the openings free of snow.

ADEQUACY: The owner said if the pipe could be kept open in the winter, it would be adequate. However, he points out that this hasn't been the case so he feels it must be classed as inadequate. He also said that personnel from the Highway Commission had assured him the pipe would be as good as his old stockpass, and inasmuch as it wasn't, he felt the State was obligated to correct the problem. He mentioned he had filed several complaints, but so far nothing had come of them. He feels the pipe should have been located farther east where it would have had more protection from the predominately southwesterly winds. The approaches are stabilized with gravel and are in good condition.

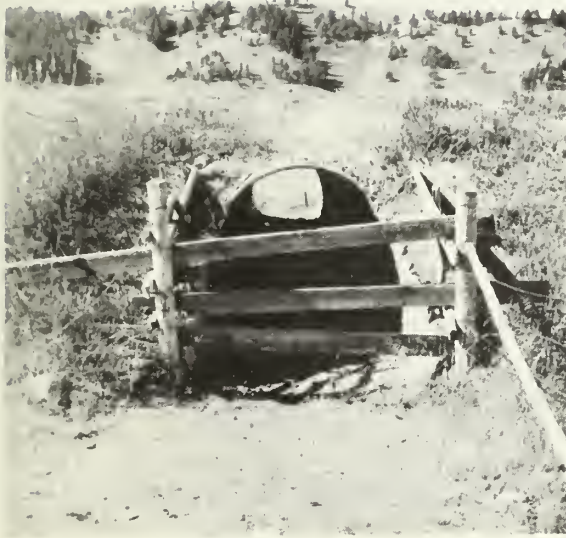
EAST ENTRANCE
3'x6" boards nailed in, during shipping

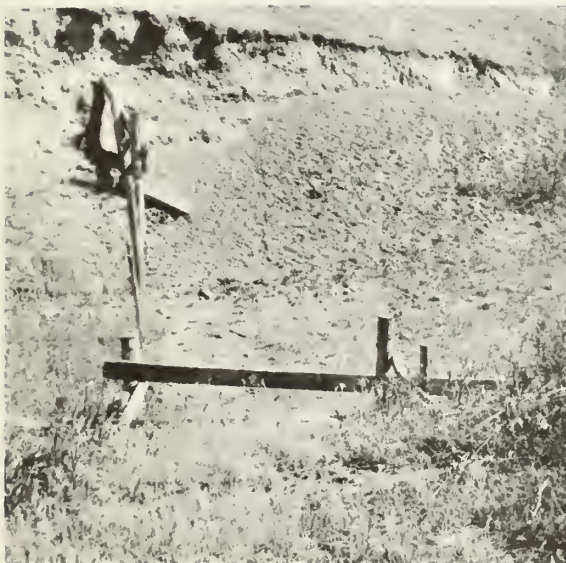
Looking East from EAST ENTRANCE
Notice trail up embankment

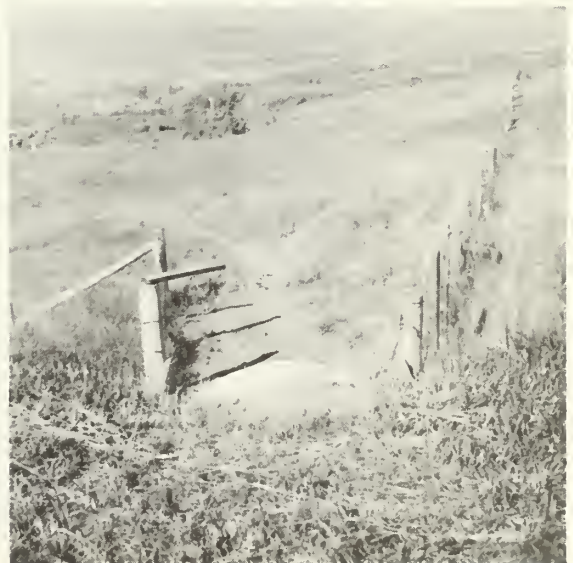
Looking West from WEST ENTRANCE
Notice trails to creek

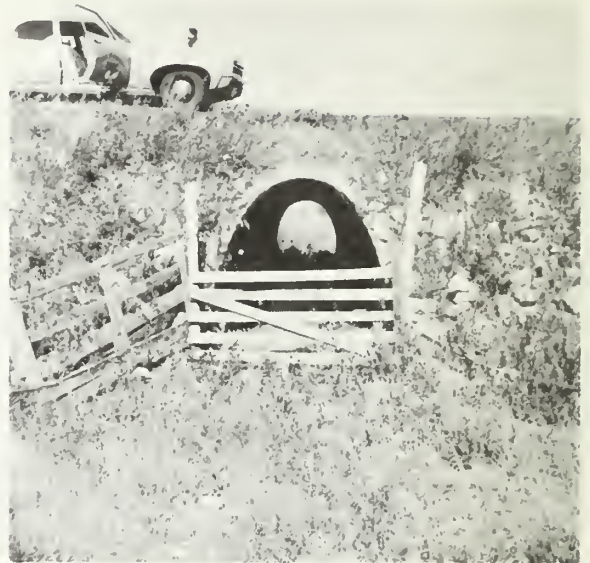
SOUTH ENTRANCE
Gate is in good repair

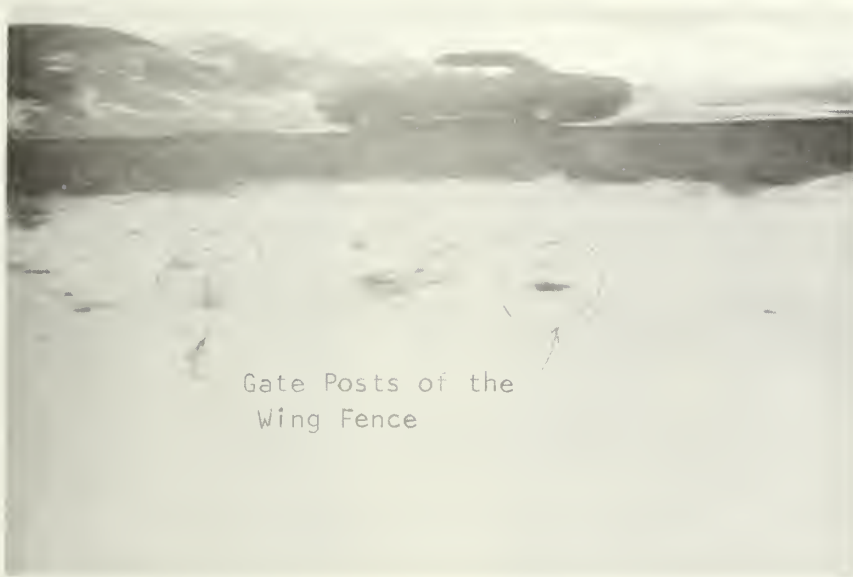
Gate Posts of the
Wing Fence

NORTH ENTRANCE
Notice Drifting Pattern of Snow

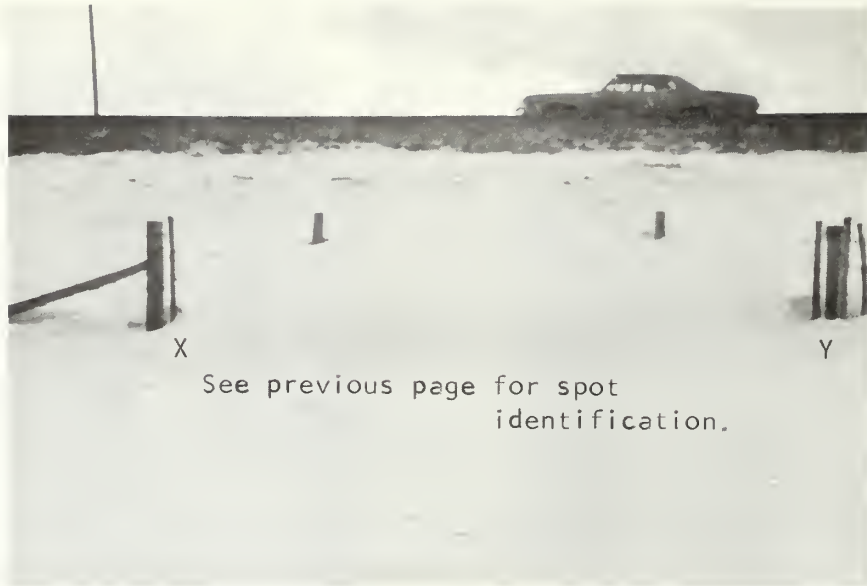
NORTH ENTRANCE
Notice drifting pattern, completely
covering the stockpass.

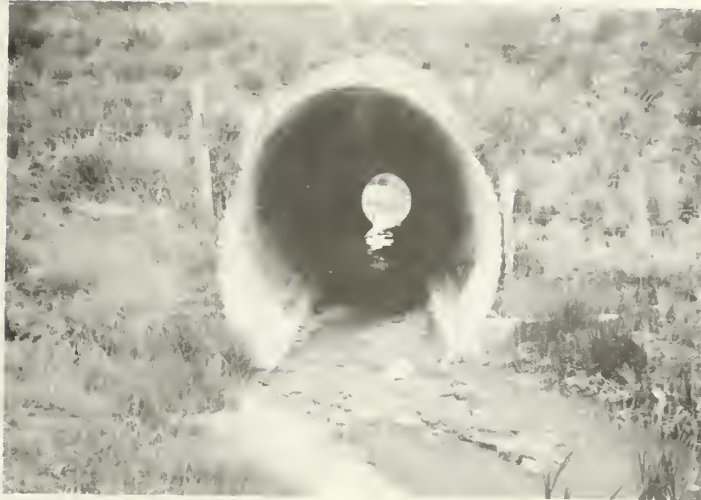
SOUTH ENTRANCE
High Water

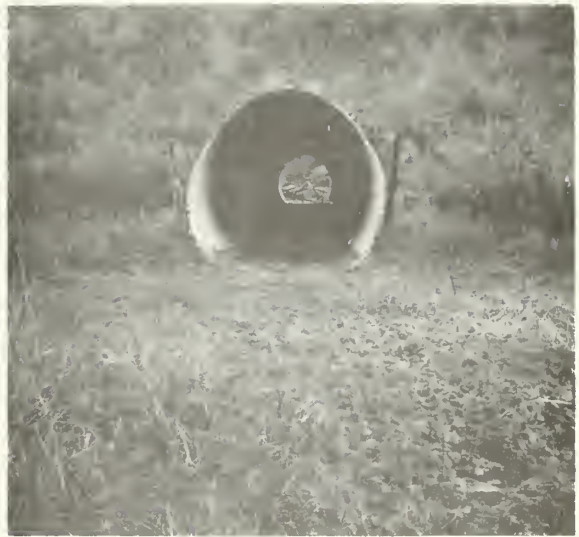
South End

Although this is in the bottom of a drainage area, notice the wide, flat bottom for easy access, winter maintenance if necessary.

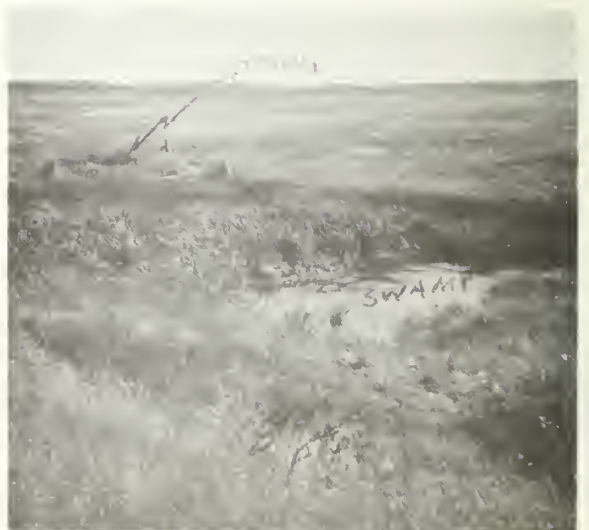
Southerly View, note
spring and swamp.

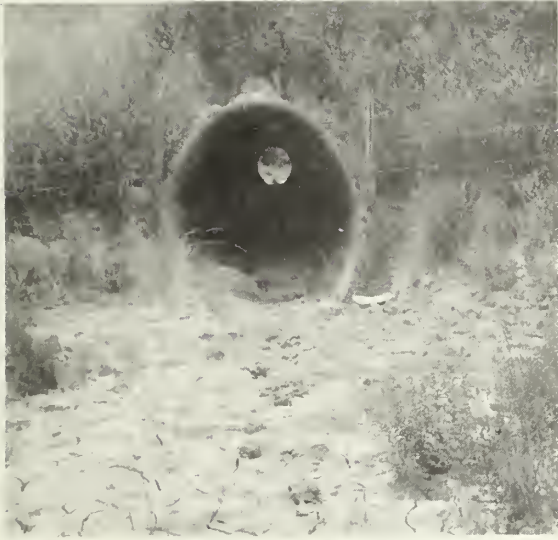
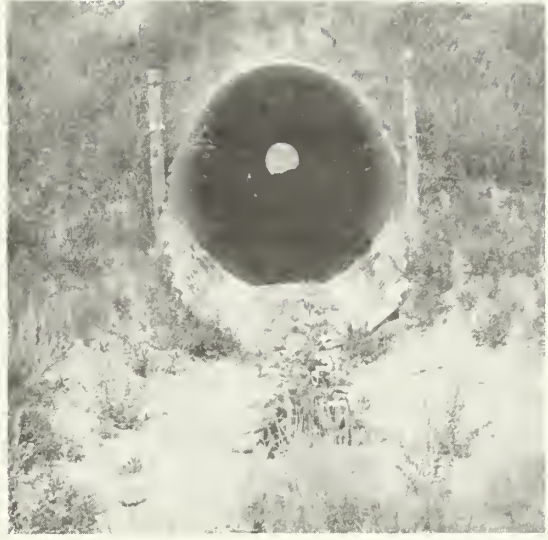
ADEQUACY: The landowner feels the structure is adequate for this type of operation. It is settling in the center and therefore the usable height is 75' and width is 85'. He feels that this structure is not quite as good as the bridge he had before. He does not, however, have the problem of the cattle turning back when traffic is crossing the pipe as he did with the bridge. It seems some problems are offset by others, with good points and bad. The main reason he liked the bridge was that it was so much wider. The investigator saw the actual cattle reaction to a vehicle crossing a bridge when a 200 to 300 head herd were crossing under a highway bridge. The cattle spooked, turned, and scattered, and seven men on horses and one pickup driver had problems handling them.

REMARKS: The landowner would not state any suggestion for improving the structure; he felt the Highway Commission should do that. The investigator felt that more care should be taken in construction to ensure proper drainage and improve the approaches with bituminous surfacing. Also, where there are large fills as this, a heavier gauge pipe might alleviate the squash and heave (bending) problem.

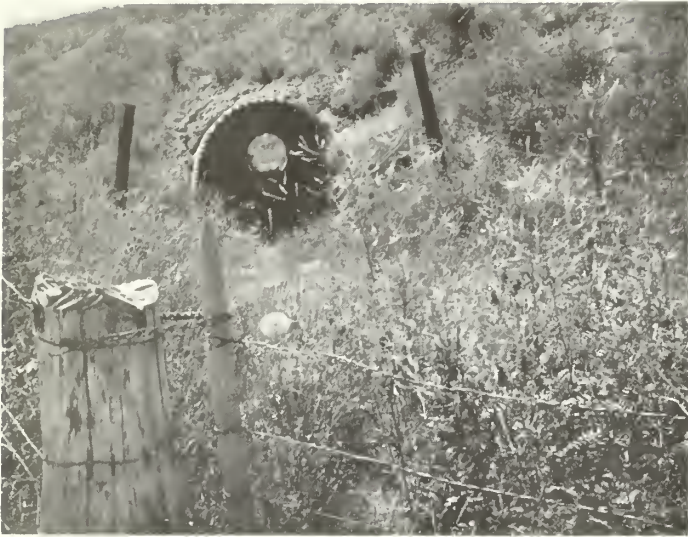
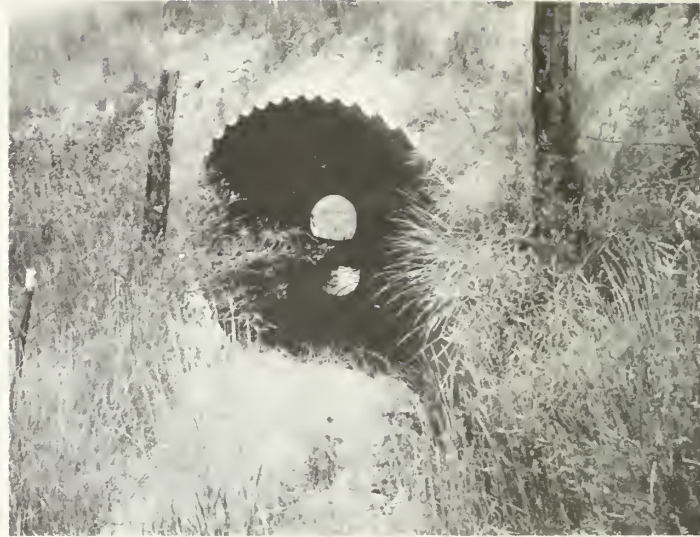
REMARKS: This structure was originally designated a drainage-stockpass; however, it has either settled or was not installed properly. Water stands in the south end for about 25 feet. There is pavement in this structure so the bottom does not constitute a problem. Terrain is rolling and accessible. Therefore, the only recommendation would be to inspect carefully the design and construction of a combination drainage-stockpass structure of this size and type.

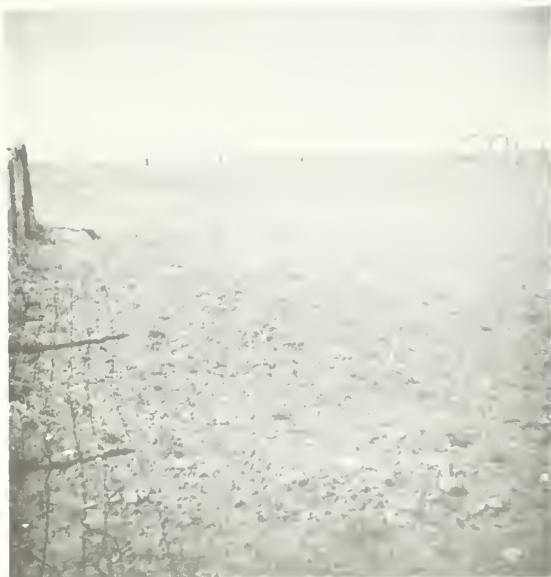
REMARKS: It is well to note the holding pen cured the difficulties first encountered. Size, shape, and type of pen should be analyzed separately for each ranching operation confronted with this problem.

Looking North from NORTH ENTRANCE
Showing the 115'x132' holding pen

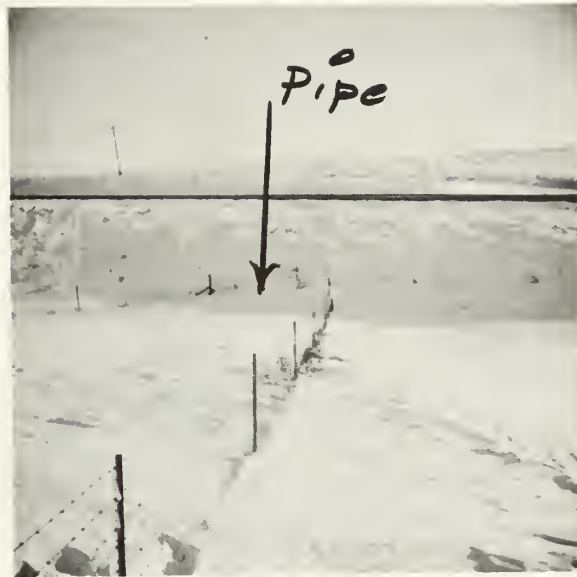
Case Study No. 54

North Entrance, January 1971. Snow has drifted this 9' diameter x 212' long stockpass.

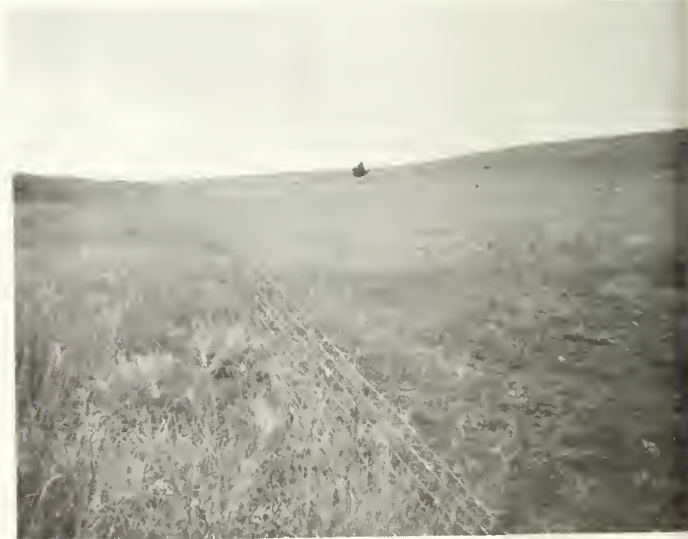
Looking Northwest from NORTH ENTRANCE
Notice pipe under old highway #10

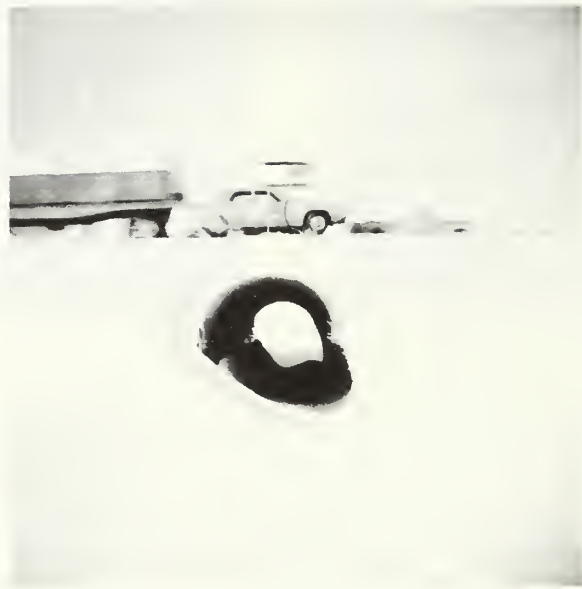
Case Study No. 59

South Entrance of Community Stockpass; photo taken during January, 1971. Wind had blown only one day, rendering this impassable.

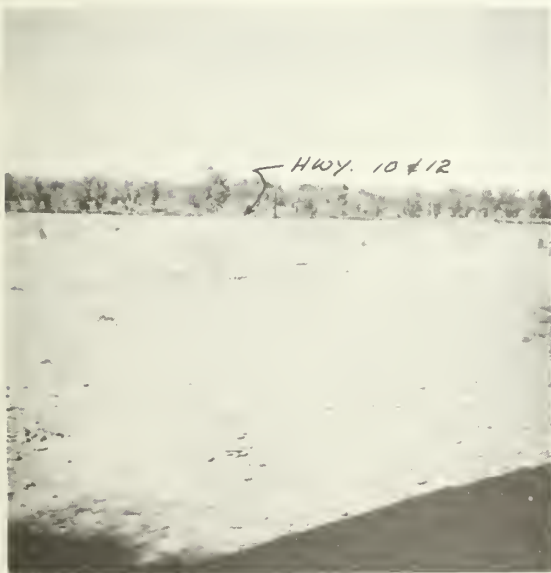
Looking North from NORTH ENTRANCE
Notice old Highway #10 roadbed

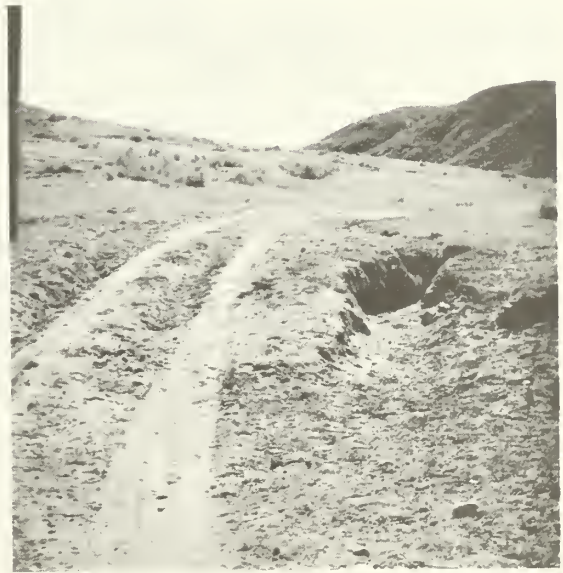
Looking South from SOUTH ENTRANCE
Notice drainage erosion

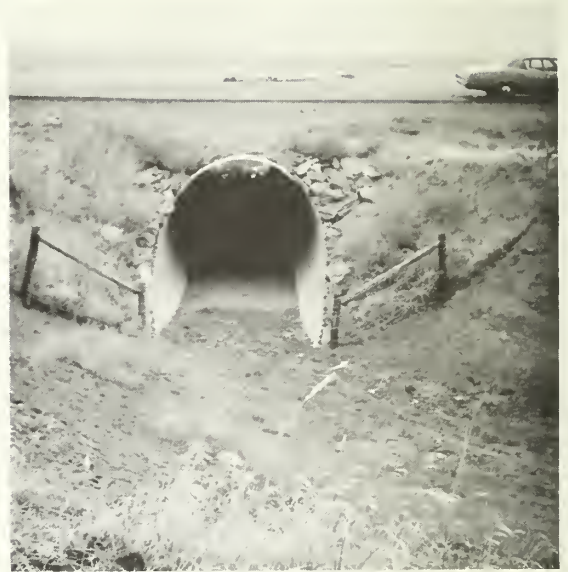
SOUTH ENTRANCE: Notice highway grade

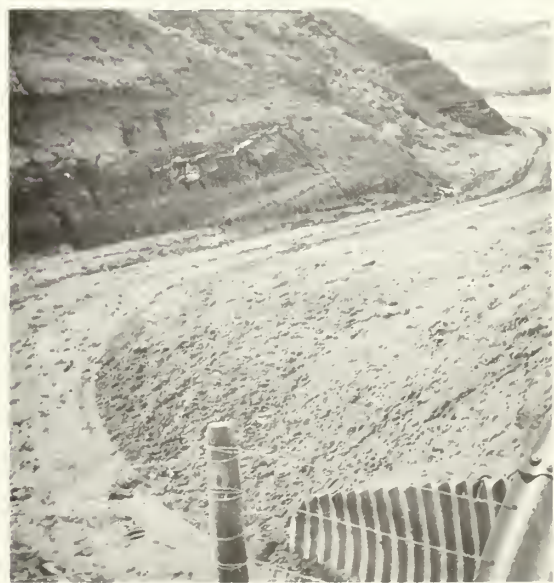
SPECIFIC PROBLEMS: Physical condition of the approach is gumbo dirt, very poor. It is practically impassable when wet and muddy. It is used primarily in the summer months for the young cattle to trail back and forth to water.

Looking South from SOUTH ENTRANCE
Gumbo road to pasture

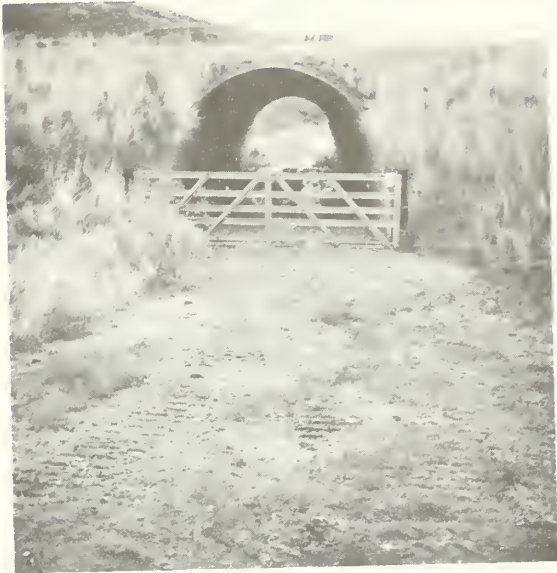
NORTH ENTRANCE

REMARKS: Whereas gravel has been hauled in for access footing, the structure still appears deficient from a drainage standpoint. Its usage was not intended to be a drain structure, but there is apparently insufficient slope to drain water through and into a drain ditch. From all appearances, this does not appear to be a correctable situation. There were better locations on neighboring lands, but this was the only feasible location on his own land. Possibly during construction more thought could have been given to proper drainage away from the structure.

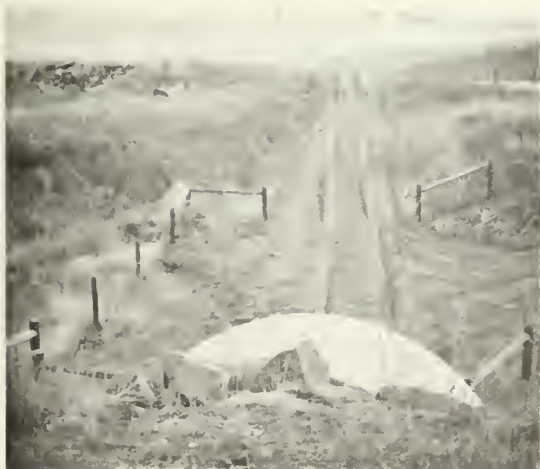
REMARKS: Whereas the photos show a good gravel approach surfacing, the south to north drainage pattern renders this inadequate during heavy rains. The location appears reasonable, but drainage consideration may have allowed this to be usable during wet periods. A separate drain pipe may have worked in this instance, if there was a place for the drainage to go north of the right-of-way.

Looking North from NORTH ENTRANCE
Notice stocklane approaches

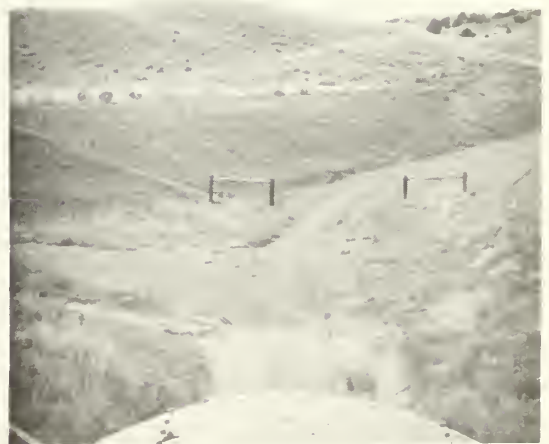
Looking South from SOUTH ENTRANCE
Notice stocklane approaches

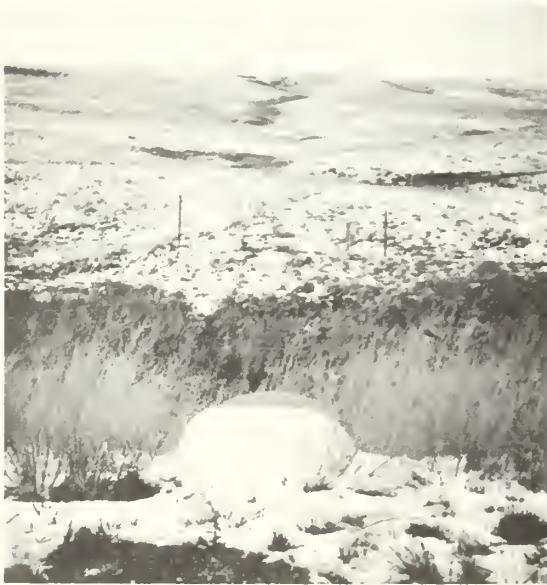
Ditch

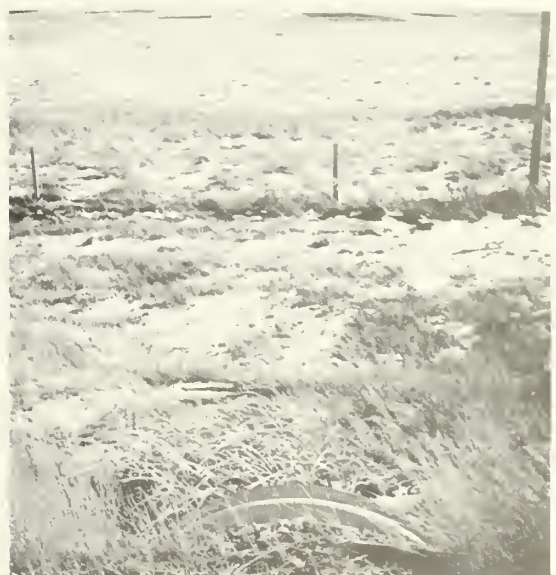
Beefstraight
Creek

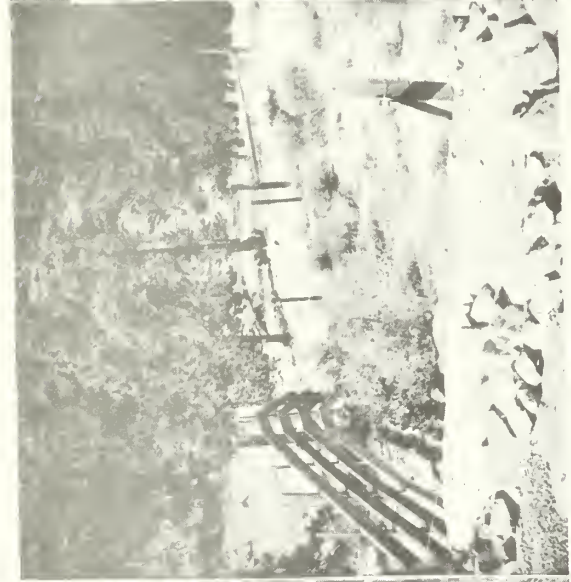
I IG 90-5 (4) Whitehall West
6'11" x 8'6" x 262' long Arch CMP

This structure is in a drainage area as evidenced by the photos; physical inspection and landowner interview show this to be a good drainage-stockpass combination.

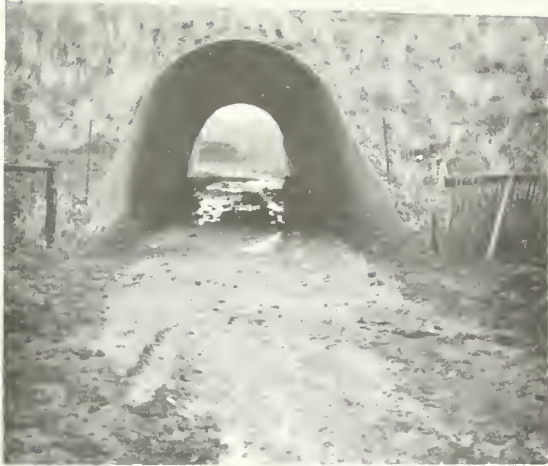
NORTHWEST ENTRANCE

ADEQUACY: The owners are satisfied with the size of the pipe and its location. They are justifiably unhappy with the mud and ice problem, considering the type of operation they run. This pipe would be considered barely adequate under certain conditions.

Apparently the present owner's father insisted on this large pipe rather than a smaller pipe, so that a loaded hay truck could drive through. It appears that the present owners have no need for such a large pipe. It is possible that when the additional two lanes are put in, this pipe could be reduced in size to get the necessary cover to keep the structure from falling in again, if this is the cause of the failure.

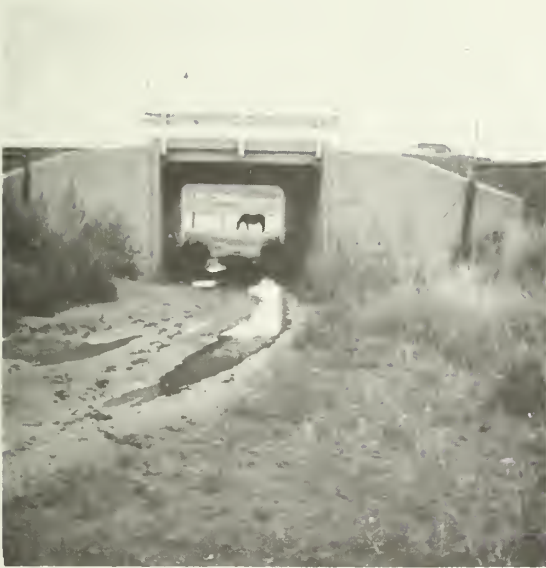
NORTH ENTRANCE

ADEQUACY: The landowner is happy with this underpass, considers it adequate, and in the best location despite its possible deficiencies. It has been here four years and still feels quite positively towards it.
